**Flood Control Project Maintenance
Levee Inspections****LMA District Cover Sheet****Spring 2014 Levee Inspection Results****Reclamation District No. 0404 Boggs**

Spring 2014 Levee Inspection Results

Reclamation District No. 0404 Boggs

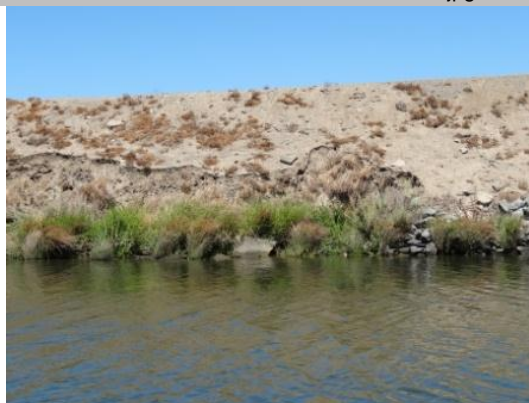
Photo 1 of 1 : richard_s_20140320_030.jpg

LM Start	0.21	Rating **	U	Issue No.	1
LM End	0.26	Issue Type +	Ma	Location *	WS
Category	Supplemental			GPS Latitude/Longitude	
				Start	End
Item	DWR Erosion Survey			37.939480 °	37.939480 °
				-121.342730 °	-121.342730 °
DWR ID	DWR_RD0404_01_s _ 2014_1				
Action/Comments					
Inspector Comments: 08/13/2013: The boat survey found the erosion has progressed significantly in size and in number of pocket erosions. 08/07/2012: The site has been visited by boat survey. The erosion has developed in size, and more pocket erosions were found. 8/23/2011: Pockets erosions observed by last survey seem to have progressed during the last flood season. Continuous monitoring of this site suggested 9/07/2010: No significant change observed on site. There is emergent vegetation at the water line. Several pocket erosions lined along the lower slope that stretches from RM 40.86 to RM 41.14. 9/30/2009: No major change observed; the site was combined with other existing sites are RM's 40.93, 40.98, and 41.14 as one site; several pocket erosion just above non-uniform toe rip rap; previously rated "U"; bare spots along the upper slope. 2008: Possibly caused by wave wash erosion; several pocket erosion along the lower slope; site is inside of a bend. 2006: Visited site 09/12/06. [2013 Site ID:RD0404U01RM40.86]

Front view of the site.

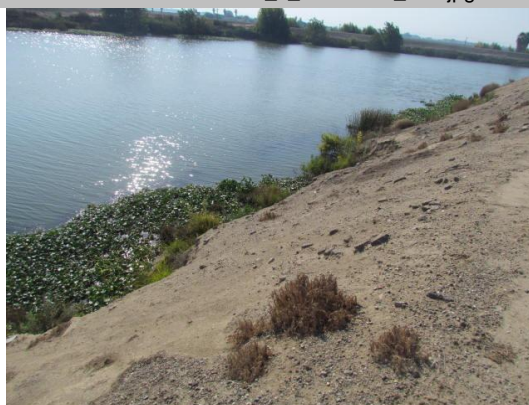
Photo 1 of 4 : richard_s_20140320_056.jpg

LM Start	0.30	Rating **	U	Issue No.	105
LM End	0.30	Issue Type +	Ma	Location *	WS
Category	Earthen Levee			GPS Latitude/Longitude	
				Start	End
Item	Erosion / Bank Caving			37.939420 °	37.939420 °
				-121.341643 °	-121.341643 °
DWR ID	DWR_RD0404_01_s _ 2012_105				
Action/Comments					
Note and monitor erosion site. Inspector Comments: Erosion appears to have increased in size.

Looking northwest at toe erosion on waterside.

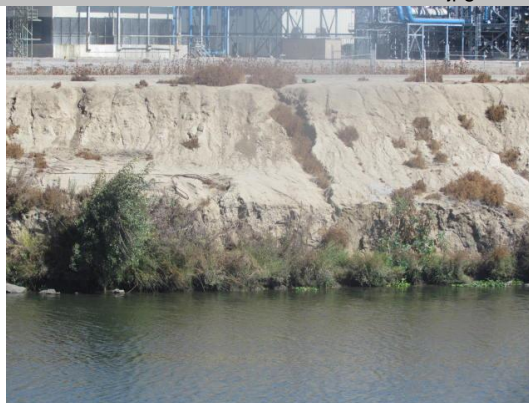
Photo 2 of 4 : richard_s_20140320_057.jpg

Looking east at erosion on slope and toe of levee.

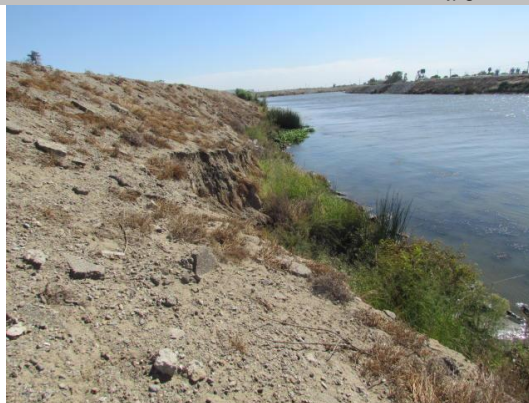
Photo 3 of 4 : richard_s_20140320_058.jpg

Looking south at erosion on waterward slope. 2013

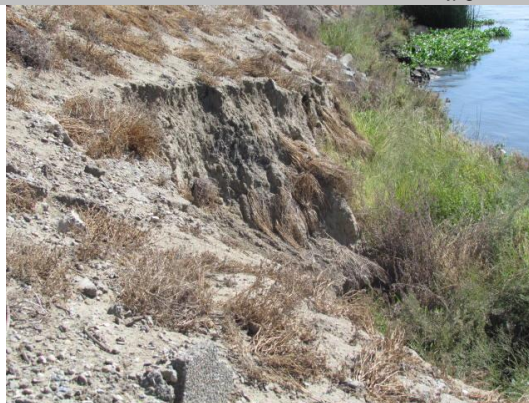
Photo 4 of 4 : richard_s_20140320_059.jpg

Looking south at erosion on waterward slope.

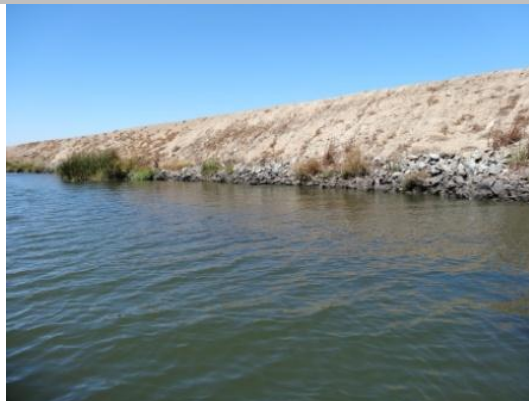
Photo 1 of 1 : richard_s_20140320_044.jpg

Looking at the erosion site from upstream.

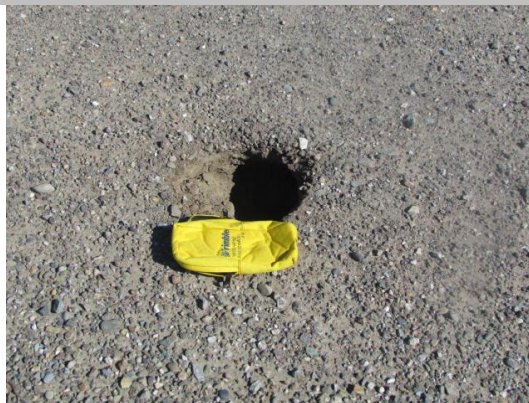
Photo 1 of 3 : richard_s_20140320_032.jpg

LM Start	0.44	Rating **	M	Issue No.	5
LM End	0.44	Issue Type +	Ma	Location *	CR
Category	Earthen Levee			GPS Latitude/Longitude	
				Start	End
Item	Animal Control			37.939635 °	37.939635 °
				-121.339063 °	-121.339063 °
DWR ID	DWR_RD0404_01_s _ 2013_5				
Action/Comments					
No rodents visible, but rodent burrows visible; need to backfill and compact or grout burrows. Inspector Comments: One large rodent hole located on levee crown and several rodent holes also located in this area. District grouted hole, but hole was not fully grouted.

Looking at rodent hole on levee crown.

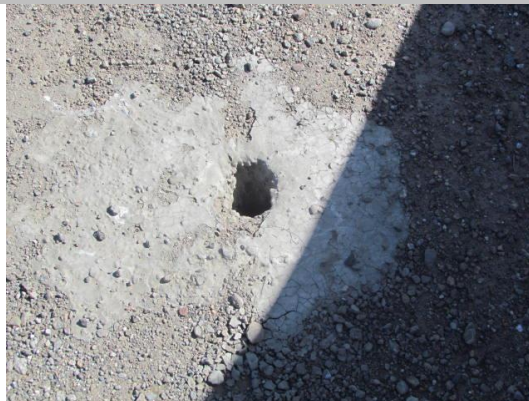
Photo 2 of 3 : richard_s_20140320_033.jpg

Looking at partially grouted rodent hole on levee crown

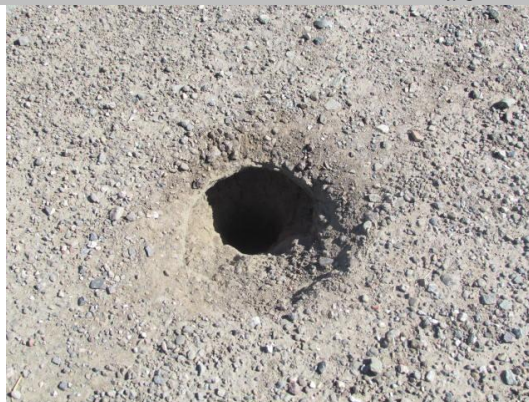
Photo 3 of 3 : richard_s_20140320_034.jpg

Looking at one of several rodent holes on levee crown.

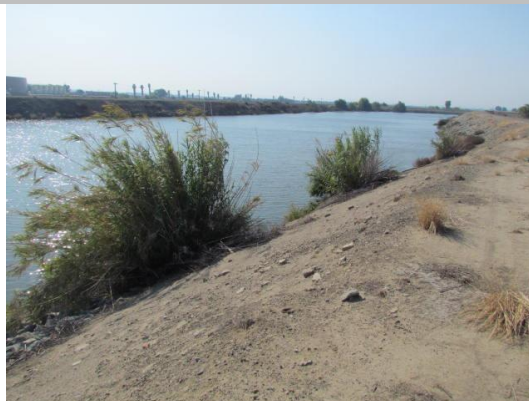
Photo 1 of 3 : richard_s_20140320_053.jpg

Looking northwest at bamboo on waterside toe.

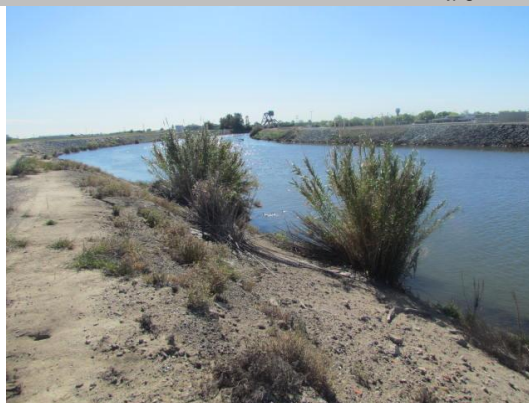
Photo 2 of 3 : richard_s_20140320_054.jpg

Looking southwest at bamboo on waterward slope and toe.

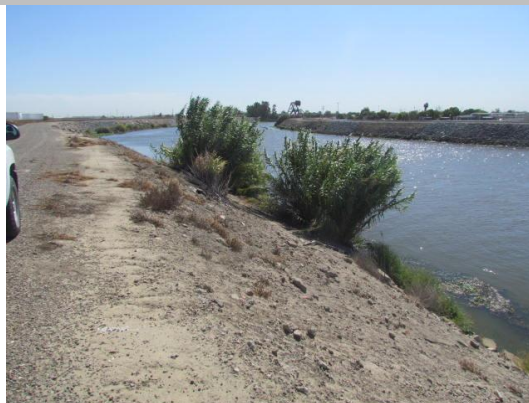
Photo 3 of 3 : richard_s_20140320_055.jpg

Looking west at bamboo on waterward slope. 2013

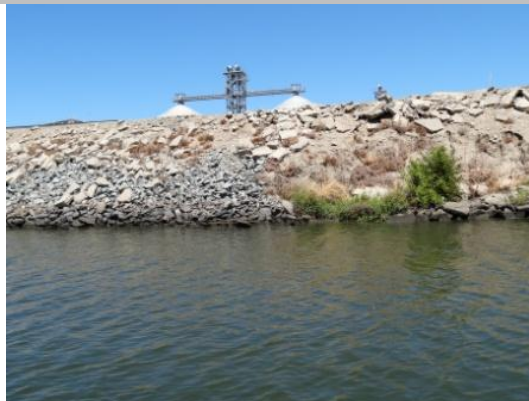
Photo 1 of 1 : richard_s_20140320_045.jpg

A closer view at the site. Note the protected bank downstream and upstream of the erosion.

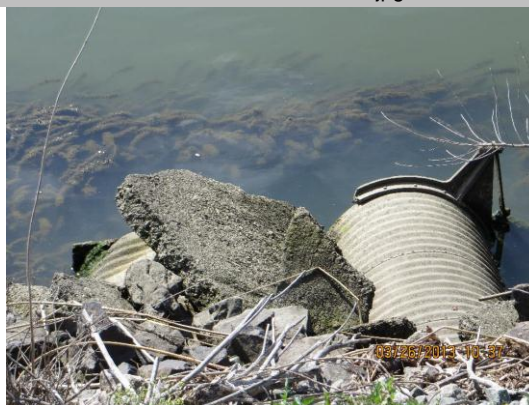
Photo 1 of 2 : UCIP_614.jpg

LM Start	0.49	Rating **	M	Issue No.	10
LM End	0.49	Issue Type +	En	Location *	WS
Category	Supplemental			GPS Latitude/Longitude	
				Start	End
Item	DWR UCIP Field Study			37.939640 °	37.939640 °
				-121.338175 °	-121.338175 °
DWR ID	DWR_RD0404_01_s_2014_10				
Action/Comments					
Inspector Comments: FS_ID:12404					
EP_NO: N/A					
Repair Type:					
Crossing Status:					
UCIP Comments:					
FIELD_STRUCT_DESC: 2 of 2. Two 36-inch corrugated metal drainage pipes. One pipe has broken flap gate.					
FS Date: 3/26/2013

WS- closer view of right CM pipe with damaged flap gate

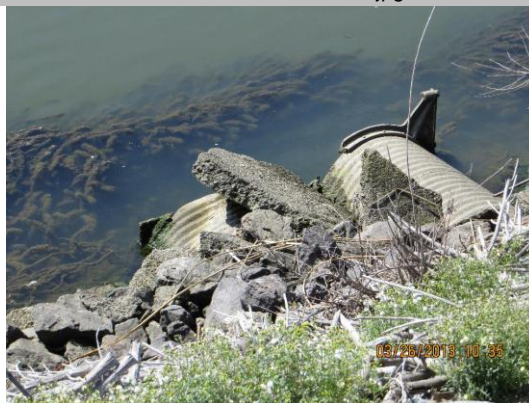
Photo 2 of 2 : UCIP_616.jpg

LM Start	0.49	Rating **	M	Issue No.	10 (cont)	
LM End	0.49	Issue Type +	En	Location *	WS	
Category	Supplemental			GPS Latitude/Longitude		
				Start	End	
Item	DWR UCIP Field Study			37.939640 °	37.939640 °	
				-121.338175 °	-121.338175 °	
DWR ID	DWR_RD0404_01_s _ 2014_10					
Action/Comments						
Inspector Comments: FS_ID:12404						
EP_NO: N/A						
Repair Type:						
Crossing Status:						
UCIP Comments:						
FIELD_STRUCT_DESC: 2 of 2. Two 36-inch corrugated metal drainage pipes. One pipe has broken flap gate.						
FS Date: 3/26/2013

WS- two CM pipes with damaged flap gates

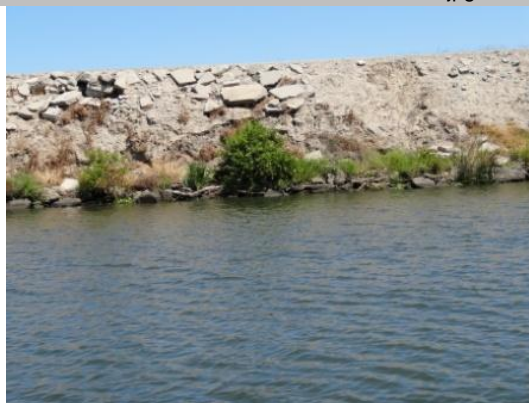
Photo 1 of 1 : richard_s_20140320_046.jpg

LM Start	0.60	Rating **	U	Issue No.	20
LM End	0.62	Issue Type +	Ma	Location *	WS
Category	Supplemental			GPS Latitude/Longitude	
				Start	End
Item	DWR Erosion Survey			37.939133 °	37.939133 °
				-121.336100 °	-121.336100 °
DWR ID	DWR_RD0404_01_s _ 2014_20				
Action/Comments					
Inspector Comments: 08/13/2013: No significant change at this site. 08/07/2012: The site was first discovered by levee inspector in the spring inspection. Levee slope was protected with broken concrete blocks, but those blocks have been washed away during high flows. [2013 Site ID:RD0404U01RM41.22]

Front view of the erosion. Note the slumping at upper slope.

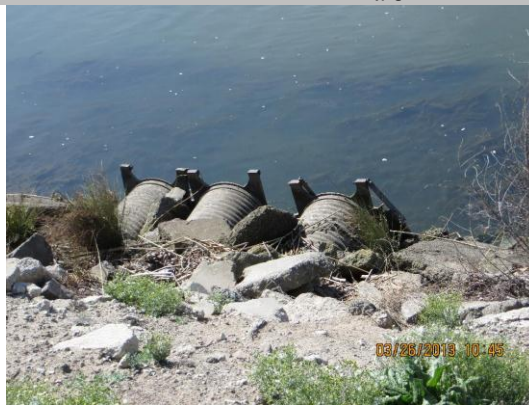
Photo 2 of 2 : UCIP_594.jpg

LM Start	0.66	Rating **	M	Issue No.	28
LM End	0.66	Issue Type +	En	Location *	WS
Category	Supplemental			GPS Latitude/Longitude	
				Start	End
Item	DWR UCIP Field Study			37.938670 °	37.938670 °
				-121.335397 °	-121.335397 °
DWR ID	DWR_RD0404_01_s_2014_28				
Action/Comments					
Inspector Comments: FS_ID:11087					
EP_NO: N/A					
Repair Type:					
Crossing Status:					
UCIP Comments: Steel intake structure on landside of the levee.					
FIELD_STRUCT_DESC: 2 of 3. 30-inch pipes through levee, 22.0 feet below the crown. Waterward end with flap gates. Landward end filled with dirt. Steel intake structure on landside of the levee. Middle flap gate missing and right flap gate broken as of 1/24/07.					
FS Date: 3/26/2013

WS- CM pipes with damaged flap gates

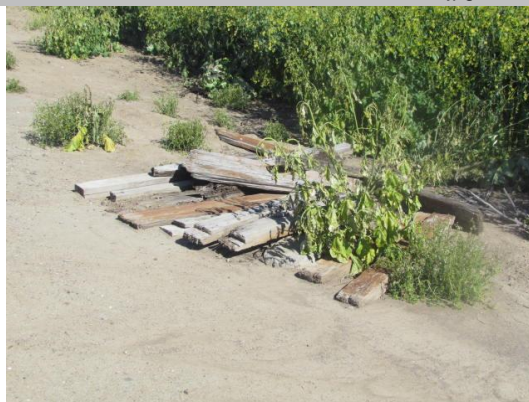
Photo 1 of 1 : richard_s_20140320_035.jpg

Looking northeast at wooden boards on landward slope.

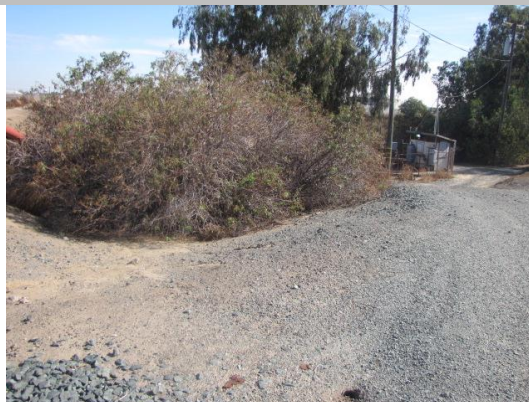
Photo 1 of 1 : richard_s_20140320_036.jpg

LM Start	0.75	Rating **	M	Issue No.	7
LM End	0.75	Issue Type +	Ma	Location *	LS
Category	Earthen Levee			GPS Latitude/Longitude	
				Start	End
Item	Vegetation			37.937758 °	37.937758 °
				-121.334149 °	-121.334149 °
DWR ID	DWR_RD0404_01_s _ 2012_7				
Action/Comments					
Elderberries are blocking visibility and flood fight capability.

Looking southeast at elderberry on landside slope.

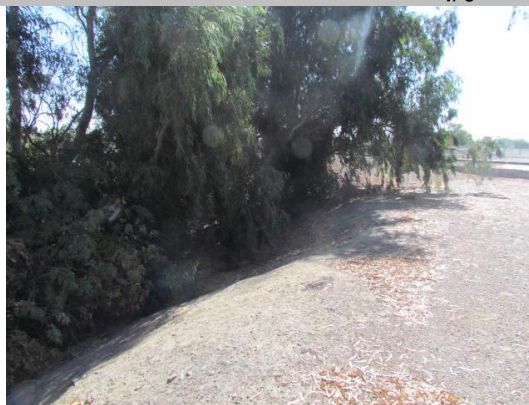
Photo 1 of 1 : richard_s_20140320_037.jpg

LM Start	0.78	Rating **	M	Issue No.	8
LM End	0.78	Issue Type +	Ma	Location *	LS
Category	Earthen Levee			GPS Latitude/Longitude	
				Start	End
Item	Trim / Thin Trees			37.937395 °	37.937395 °
				-121.333883 °	-121.333883 °
DWR ID	DWR_RD0404_01_s_2013_8				
Action/Comments					
Trim trees to at least five feet above ground level. Inspector Comments: Trees blocking view of slope.

Looking southeast at dense trees on landward slope and toe.

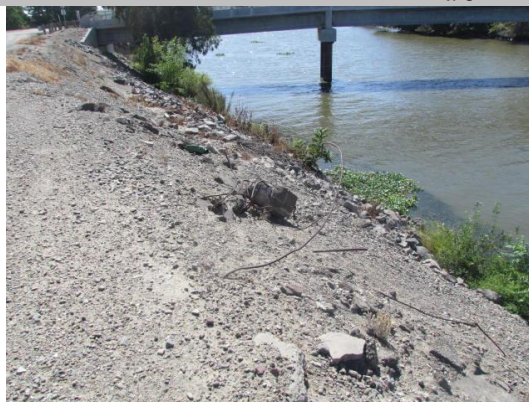
Photo 1 of 1 : richard_s_20140320_031.jpg

Looking southwest at concrete rubble with rebar on waterward slope.

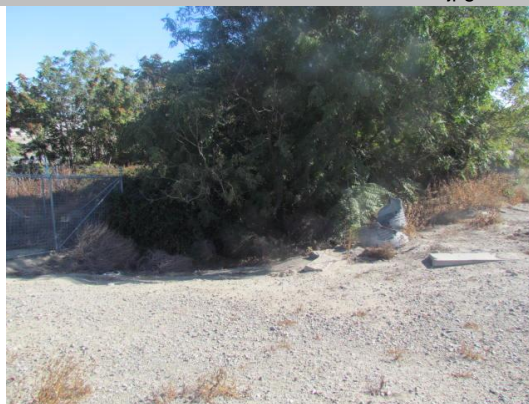
Photo 1 of 1 : richard_s_20140320_052.jpg

LM Start	1.20	Rating **	M	Issue No.	101
LM End	1.20	Issue Type +	Ma	Location *	LS
Category	Earthen Levee			GPS Latitude/Longitude	
				Start	End
Item	Vegetation			37.934058 °	37.934058 °
				-121.328188 °	-121.328188 °
DWR ID	DWR_RD0404_01_s _ 2012_101				
Action/Comments					
Remove the wild growth other than native grasses from the levee slopes.

Looking southeast at overhanging trees on landside slope.

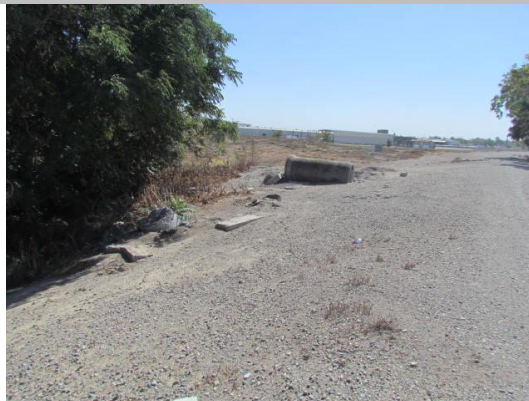
Photo 1 of 2 : richard_s_20140320_038.jpg

Looking southeast at old broken concrete pipes on landward slope and toe.

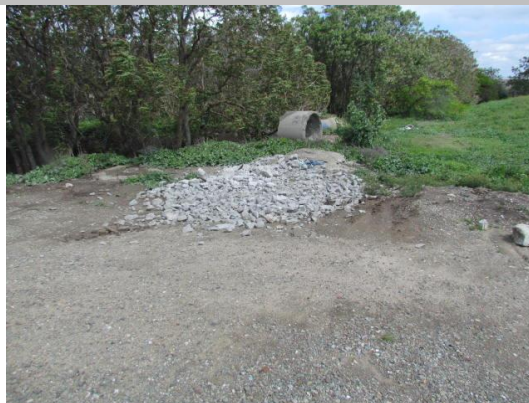
Photo 2 of 2 : richard_s_20140403_505.jpg

Looking east at broken concrete and concrete pipes on landward slope.

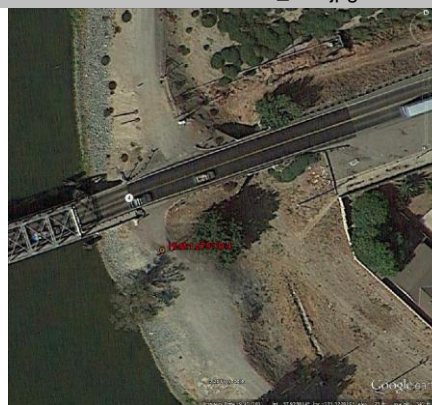
Photo 1 of 1 : UCIP_601.jpg

Aerial Photo @HLM=1.5791: No sign posts/markers found.

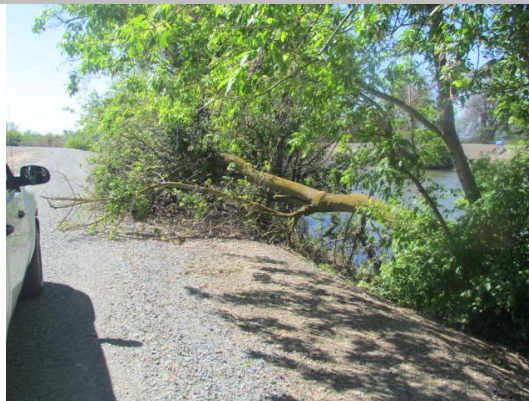
Photo 1 of 2 : richard_s_20140320_047.jpg

Looking south at broken tree branch on waterward shoulder and slope.

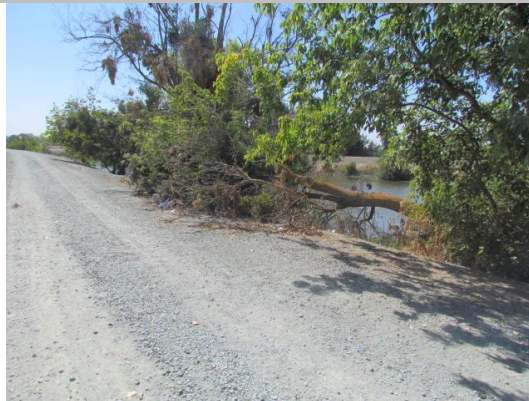
Photo 2 of 2 : richard_s_20140320_048.jpg

Looking southwest at fallen tree limb on waterward slope. 2013

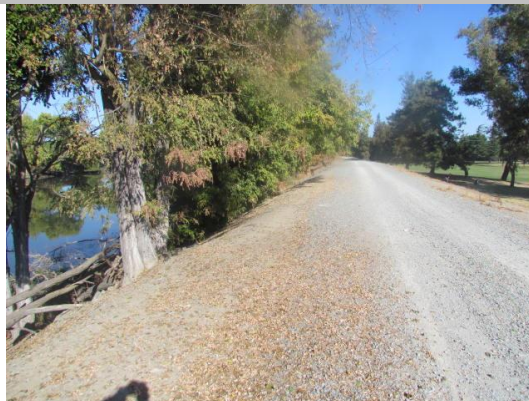
Photo 1 of 1 : richard_s_20140320_051.jpg

LM Start	1.98	Rating **	A/W	Issue No.	99
LM End	1.98	Issue Type +	Ma	Location *	WS
Category	Earthen Levee			GPS Latitude/Longitude	
				Start	End
Item	Trim / Thin Trees			37.924055 °	37.924055 °
				-121.323195 °	-121.323195 °
DWR ID	DWR_RD0404_01_s _ 2012_99				
Action/Comments					
Trim trees to at least five feet above ground level.

Looking southwest at dense trees on waterside slope.

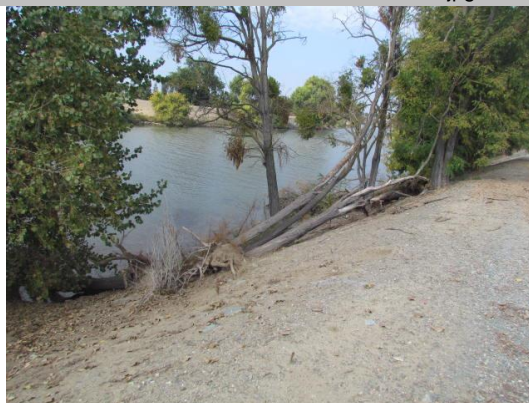
Photo 1 of 1 : richard_s_20140320_050.jpg

Looking northwest at downed tree on waterside slope.

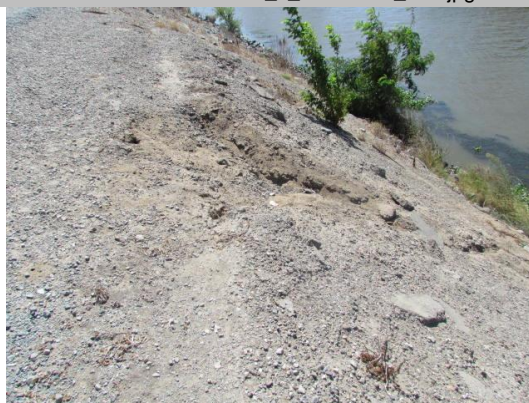
Photo 1 of 2 : richard_s_20140320_042.jpg

LM Start	2.01	Rating **	M	Issue No.	16
LM End	2.01	Issue Type +	Ma	Location *	WS
Category	Earthen Levee			GPS Latitude/Longitude	
				Start	End
Item	Slope Stability				o
					o
DWR ID	DWR_RD0404_01_f _ 2013_16				
Action/Comments					
Repair the levee slope damaged by foot traffic and prevent access where possible.					
Inspector Comments: Slope damage due to foot traffic.

Looking southwest at slope damage due to foot traffic.

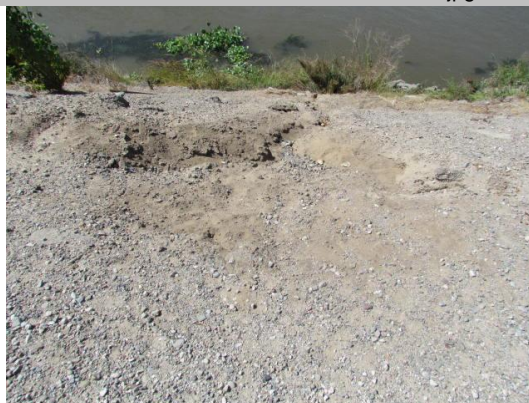
Photo 2 of 2 : richard_s_20140320_043.jpg

Looking west at slope damage due to foot traffic.

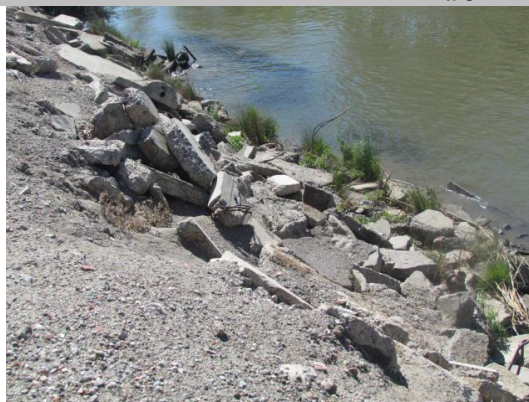
Photo 1 of 1 : richard_s_20140320_049.jpg

Looking southwest at concrete rip rap with rebar.

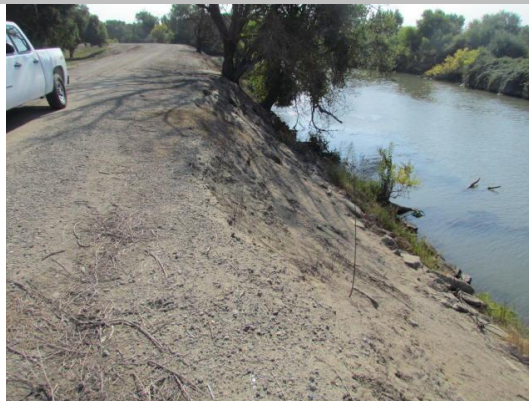
Photo 1 of 1 : richard_s_20140320_096.jpg

LM Start	0.11	Rating **	M	Issue No.	75
LM End	0.11	Issue Type +	Ma	Location *	WS
Category	Earthen Levee			GPS Latitude/Longitude	
				Start	End
Item	Erosion / Bank Caving			37.919207 °	37.919207 °
				-121.316852 °	-121.316852 °
DWR ID	DWR_RD0404_02_s _ 2012_75				
Action/Comments					
Schedule repair of erosion site prior to the next inspection.

Looking west at waterside slope erosion.

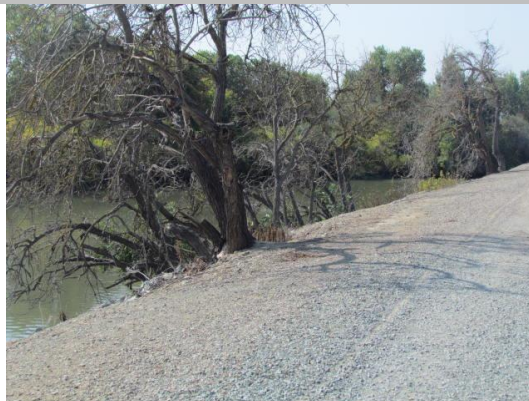
Photo 1 of 2 : richard_s_20140320_094.jpg

Looking northwest at dead trees on waterside slope.

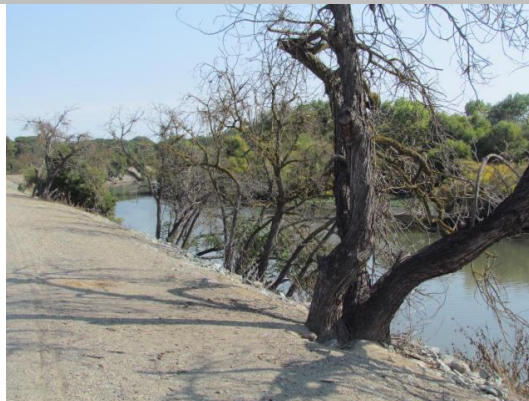
Photo 2 of 2 : richard_s_20140320_095.jpg

Looking southwest at dead trees on waterside slope.

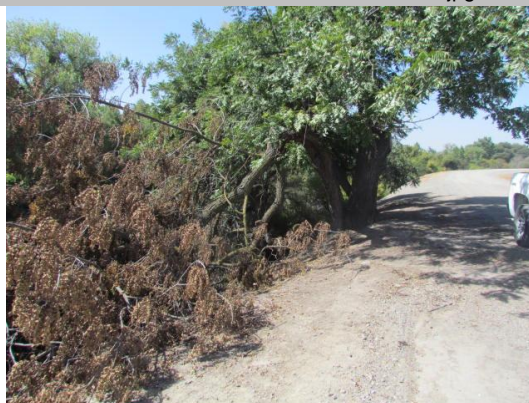
Photo 1 of 1 : richard_s_20140320_070.jpg

LM Start	0.24	Rating **	M	Issue No.	2	
LM End	0.24	Issue Type +	En	Location *	WS	
Category	Earthen Levee			GPS Latitude/Longitude		
				Start		End
Item	Encroachments				°	°
					°	°
DWR ID	DWR_RD0404_02_f_2013_2					
Action/Comments						
Tree or limb						
Inspector Comments: Broken tree limb on waterward slope.and sofe

Looking northwest at broken tree limb on waterward shoulder and slope.

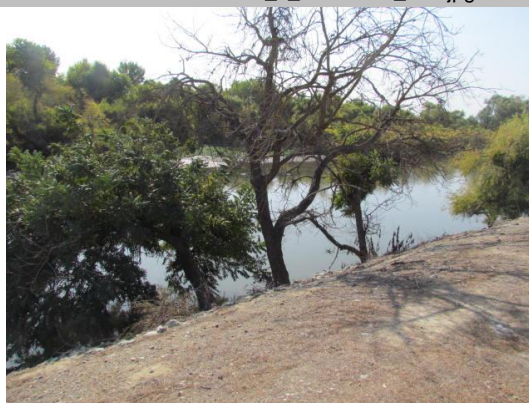
Photo 1 of 1 : richard_s_20140320_093.jpg

Looking east at dead tree on waterside slope.

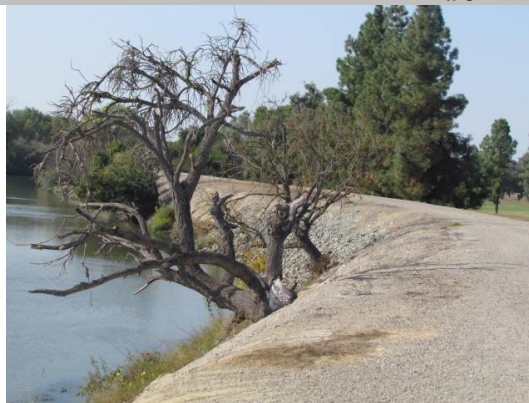
Photo 1 of 1 : richard_s_20140320_092.jpg

Looking northwest at dead tree on waterside slope.

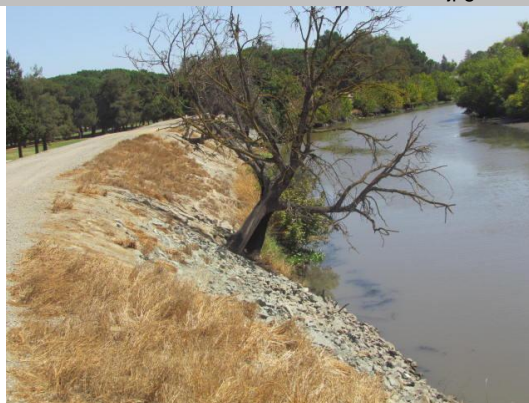
Photo 1 of 1 : richard_s_20140320_091.jpg

Looking south at dead tree on waterward slope.

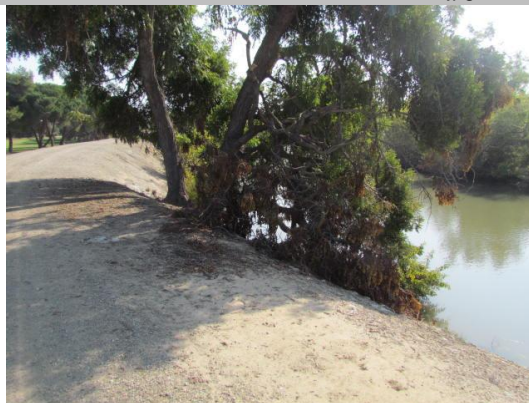
Photo 1 of 2 : richard_s_20140320_089.jpg

Looking southeast at downed tree limb on waterside slope.

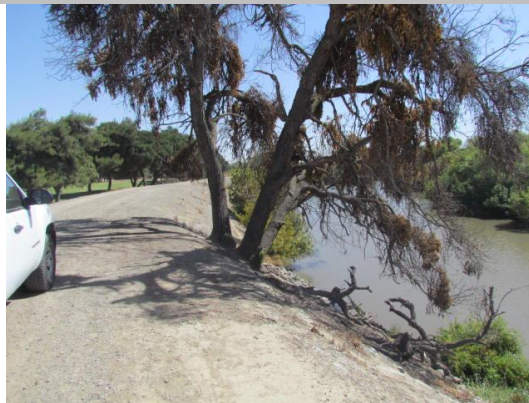
Photo 2 of 2 : richard_s_20140320_090.jpg

Looking south at dead tree on waterward slope.

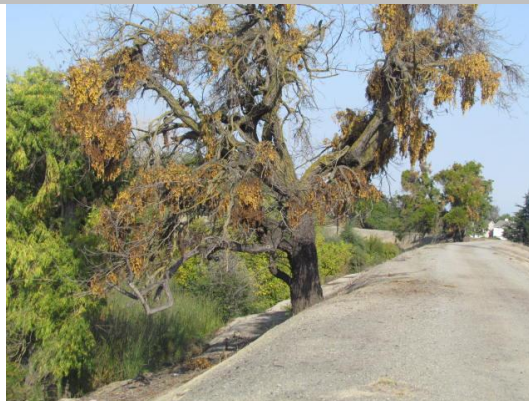
Photo 1 of 1 : richard_s_20140320_088.jpg

Looking northwest at dead tree on waterside slope.

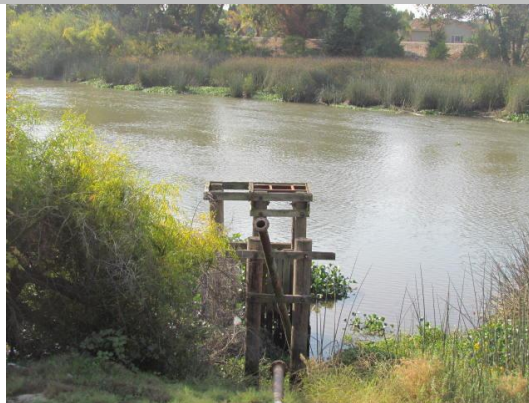
Photo 1 of 4 : richard_s_20140320_082.jpg

Looking southwest at wooden pump stand in channel.

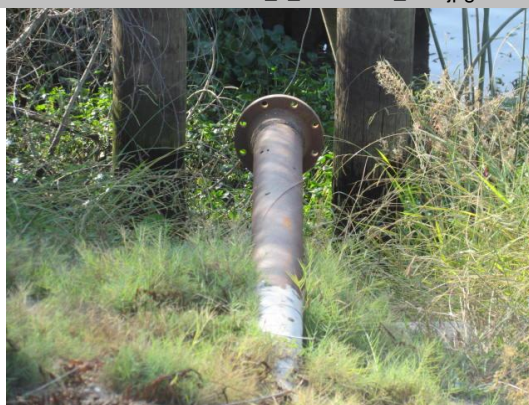
Photo 2 of 4 : richard_s_20140320_083.jpg

Looking south at 4-6" pipe on waterside slope.

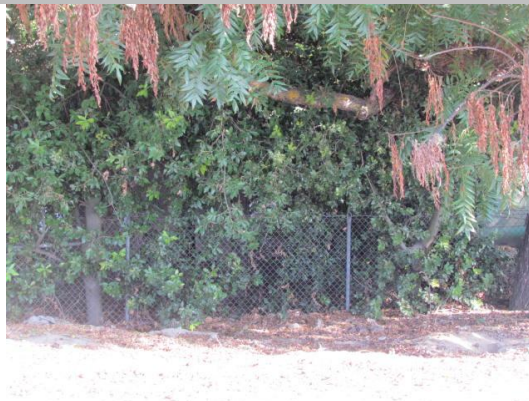
Photo 1 of 4 : richard_s_20140320_084.jpg

Looking northeast at dense vegetation inside fenced area near pump station on landside toe.

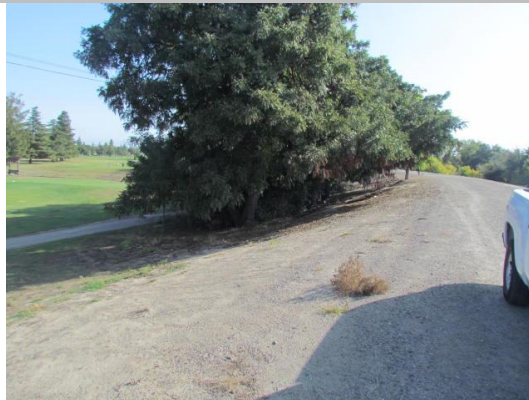
Photo 2 of 4 : richard_s_20140320_085.jpg

Looking east at dense vegetation near pump station on landside toe.

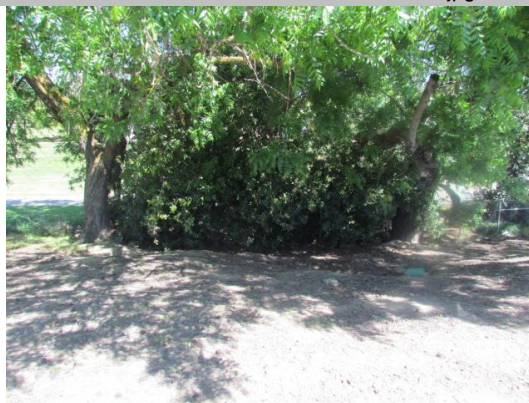
Photo 3 of 4 : richard_s_20140320_086.jpg

Looking northeast at dense vegetation on landward toe. (Spring 2013)

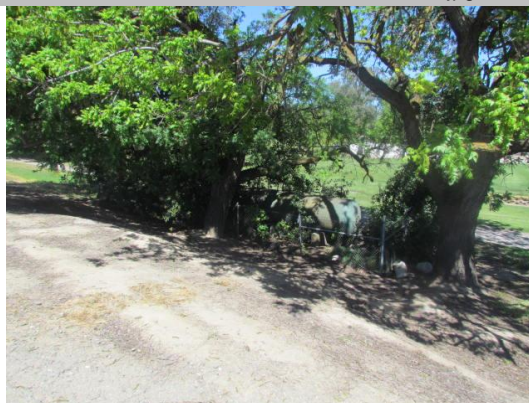
Photo 4 of 4 : richard_s_20140320_087.jpg

Looking north at dense vegetation on landward toe around propane tank.

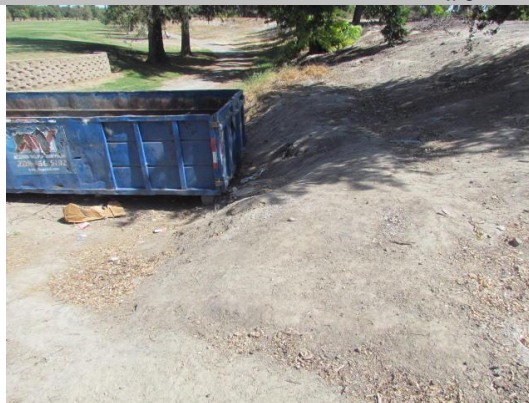
Photo 1 of 1 : richard_s_20140320_074.jpg

Looking southeast at dumpster and landside erosion on landward toe.

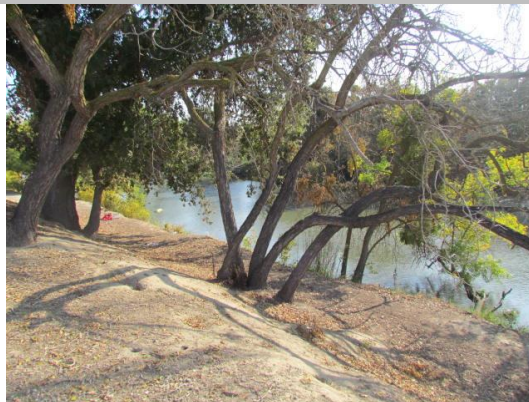
Photo 1 of 1 : richard_s_20140320_081.jpg

Looking southwest at several dead trees on waterside slope.

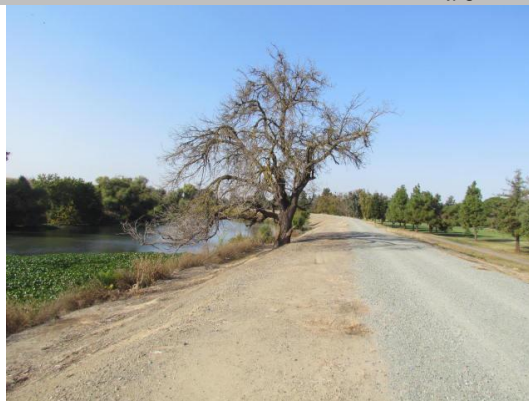
Photo 1 of 1 : richard_s_20140320_080.jpg

Looking east at dead tree on waterside slope.

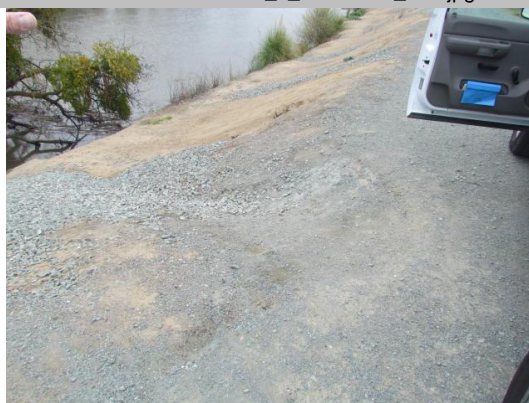
Photo 1 of 2 : richard_s_20140320_068.jpg

Looking south at one of several foot traffic erosion on waterside slope.

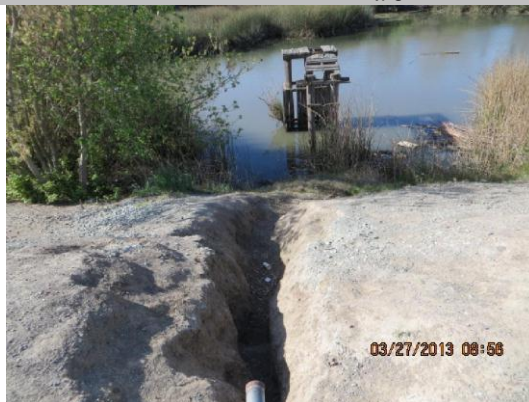
Photo 1 of 1 : UCIP_387.jpg

WS- soil erosion and gully formation due to leaky pipe

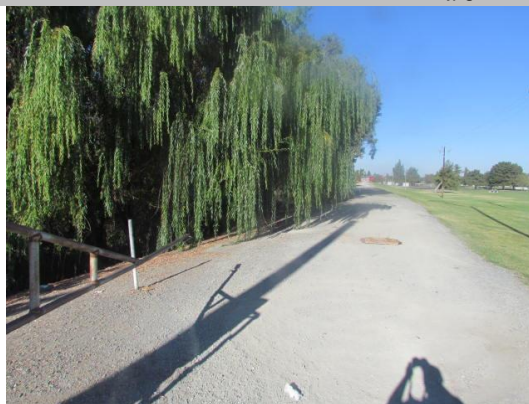
Photo 1 of 1 : richard_s_20140320_076.jpg

Looking west at overhanging tree on waterside slope.
